April 4, 2025
Project No. 2302435

Re: **White Cloud Dam Recommendation Letter**
White Cloud, Michigan

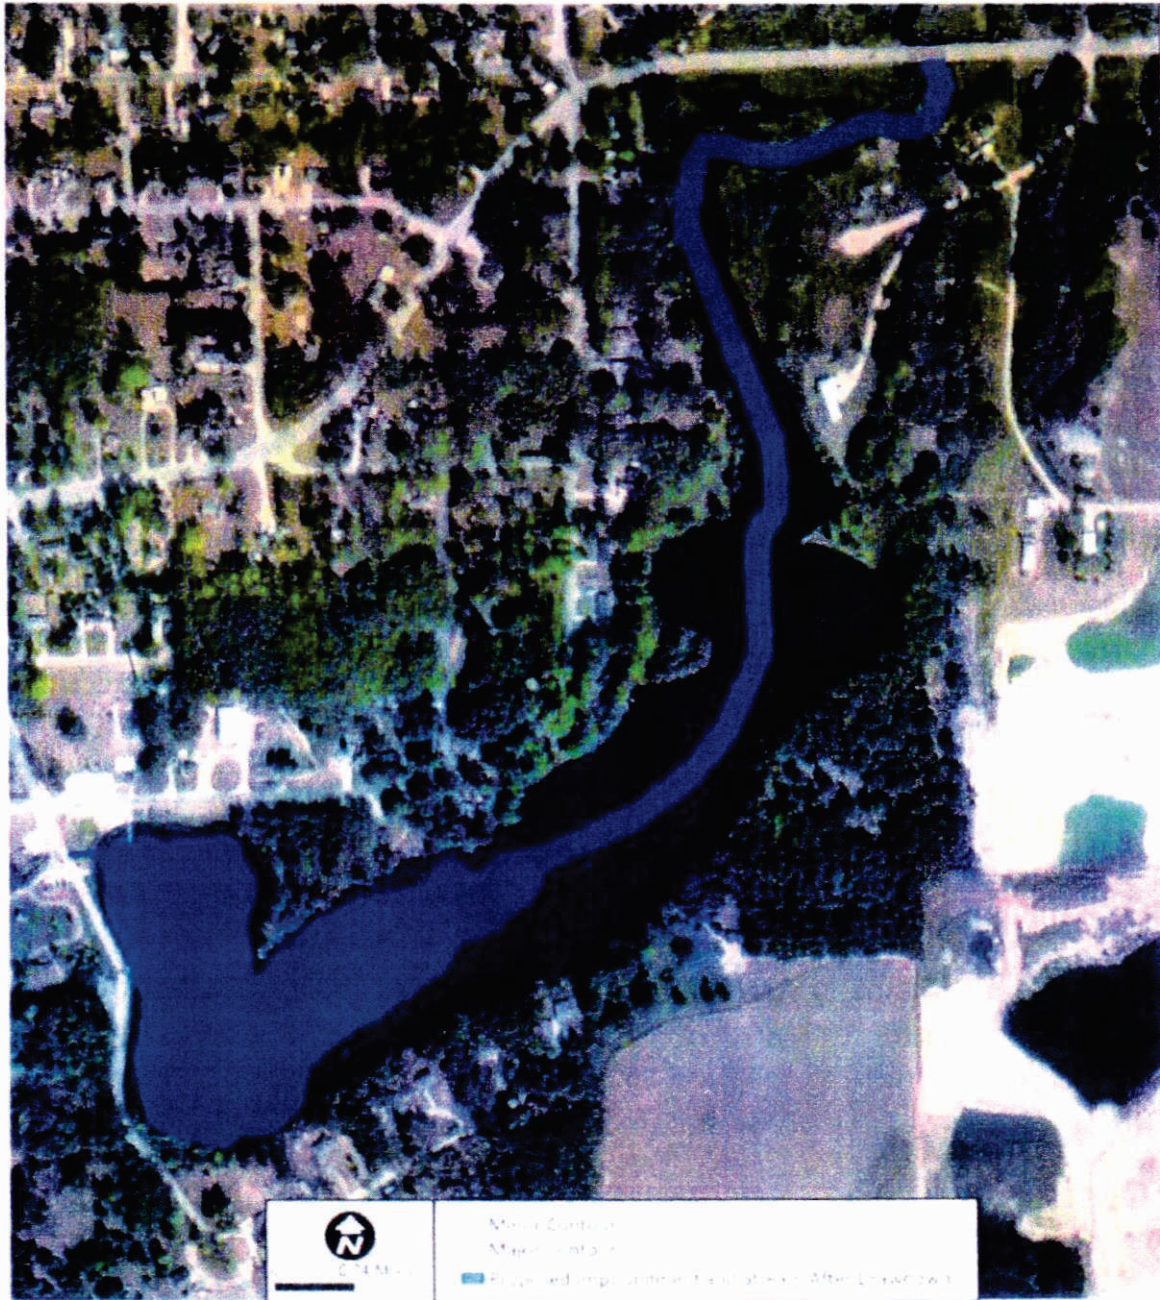
The recommended drawdown will lower the normal water surface elevation in the impoundment approximately 6-7 feet during normal flows, like what was seen in late August/early September 2024. The approximate limits of the new impoundment during normal flow are depicted in Figure 1 below.

Figure 1. Approximate limits of White Cloud impoundment after drawdown during normal flow.

The dam safety deficiencies of greatest immediate concern are the lack of sufficient hydraulic capacity and the seepage and insufficient global factor of safety at the right earthen dam embankment. A drawdown of the impoundment is recommended to lower the risk associated with these deficiencies. The water level within the impoundment should be lowered to the maximum extent possible by removing all stop logs from both the primary and auxiliary spillways.

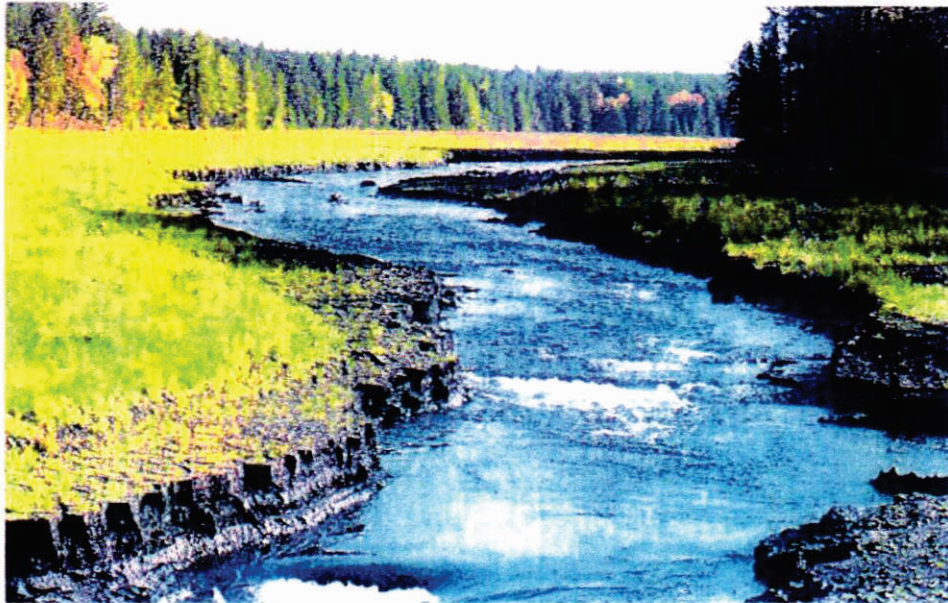
The drawdown will expose impounded sediment, primarily in the upper impoundment area and edges of the current impoundment, and in the near term following the drawdown there will be bare soil exposed. The native seed bank held within the soils will fairly quickly (2-3 weeks) germinate and green vegetation will establish (2-3 months), similar to Figure 2.

Figure 2. Pigeon River cuts a channel through the muck where there once was an eight-foot-deep impoundment behind the dam. (Photo Credit: Howard Meyerson)
